# Building Inspection Report

123 Sherlock Ct; Bloomington, IN 47401

**Inspection Date:**  
07/23/2013

**Prepared By:**  
Sherlock Homes Inspection Svc., Inc.

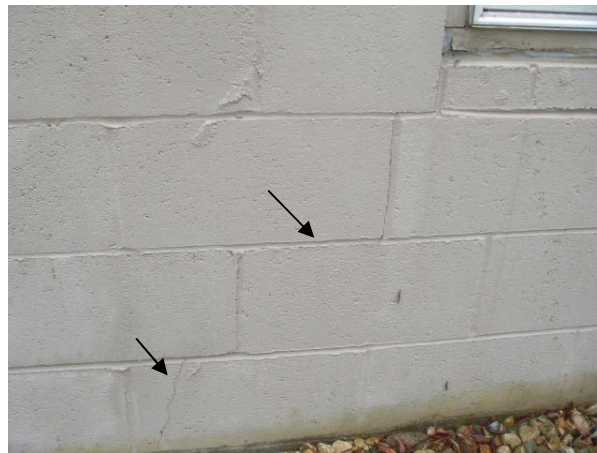
**Location of condition:**      **North side of the foundation.**

- **Monitor:** Common minor settlement cracks were observed in the foundation walls. This implies that some structural movement of the building has occurred. Cracks of this type should be watched for any sign of additional movement. In the absence of any sign of ongoing movement, repair should not be necessary.

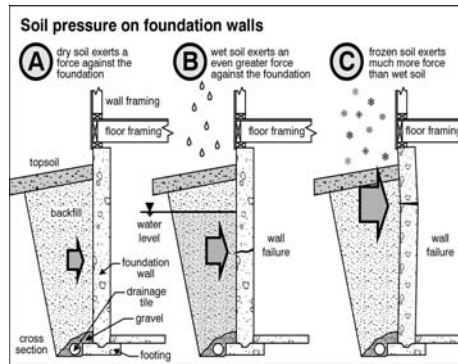
**Location of condition:**            **West basement foundation wall.**

- **Monitor:** There appears to be too much soil or backfill against an un-reinforced foundation wall. Excessive depth of soil may contribute or cause movement in the foundation. The maximum depth of soil is limited by the thickness of the wall. For example the maximum depth of soil against an un-reinforced 8-inch concrete block is 4 feet while the maximum depth of soil against an un-reinforced 12-inch concrete block is 7 feet. It is critical that water runoff is kept well away from the foundation wall so that movement related to hydrostatic pressure can be kept to a minimum.

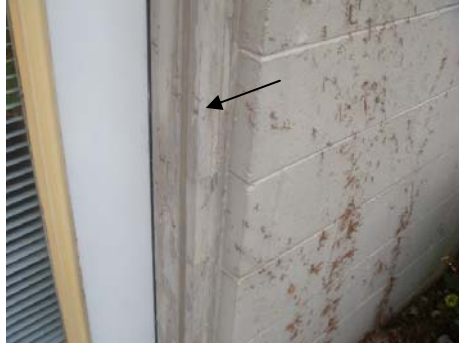
**Location of condition:** Wood trims around the living room east exit door.

- **Improve:** The exterior finishes are in need of painting or staining. Repairs should be undertaken to avoid further deterioration of the building.

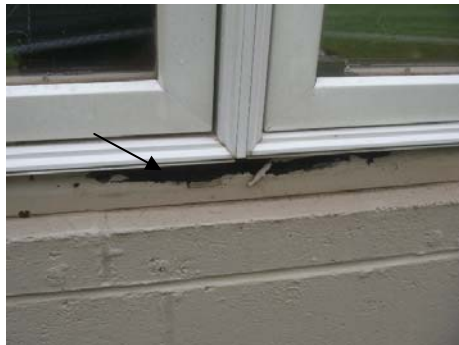
**Location of condition:** Both basement north windows.

- **Repair:** The window trim and/or sill are rotten. The deteriorated wood is conducive to wood destroying insect infestation and should be repaired or replaced as soon as possible.

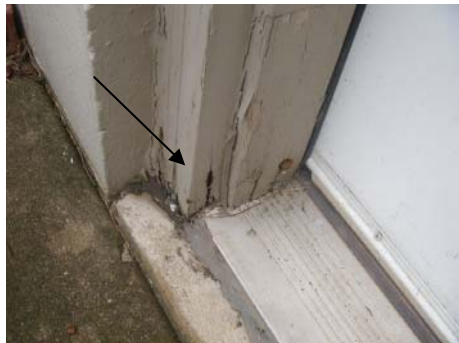
**Location of condition:** Basement exit door.

- **Repair:** The door trim and/or sill are rotten. The deteriorated wood is conducive to wood destroying insect infestation and should be repaired or replaced as soon as possible.

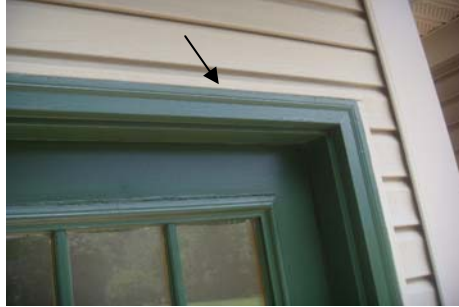
**Location of condition:** Above the garage service door.

- **Improve:** The head flashing and/or drip cap is missing above the door(s). The flashing should be designed to divert water, which may collect on top of the door trim. In lieu of flashing, caulking between the door trim and siding may help to prevent water accumulation.

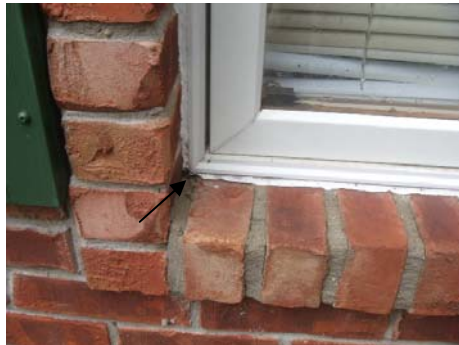
**Location of condition:** Between some of the windows and the brick veneer.

- **Improve:** The caulking where the windows, doors, and/or sidings adjoins the brick veneer appears to be in poor condition or is missing. It is important that this area be well sealed to help prevent water from entering the wall cavity.

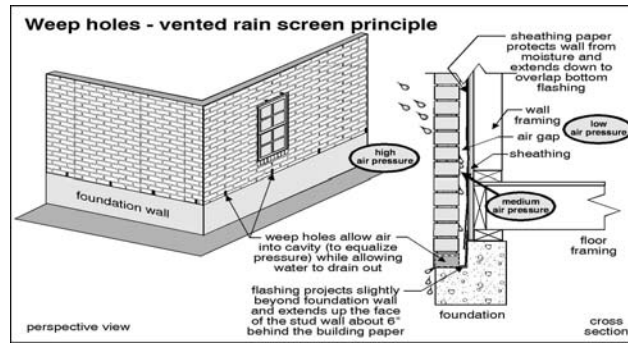
- **Monitor:** The veneer lacks weep holes. The absence of weep holes may allow water to accumulate in the wall cavity. Weep holes are often omitted and many times their omission does not create a deficiency. If heavy efflorescence is observed on the veneer, trapped water may be indicated, the installation of working weep holes may be required.

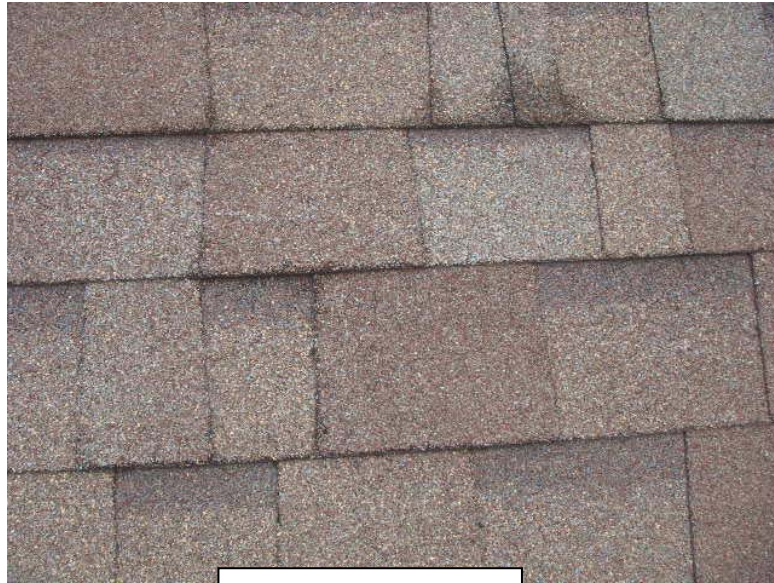
- **Monitor:** The roof surface is worn. The amount of deterioration appeared to be consistent on all roof surfaces. Typically this type of roof surface will last 20 to 25 years. It will not be possible for the inspector to determine the age of the roof.

Roof surface worn, but in fair condition

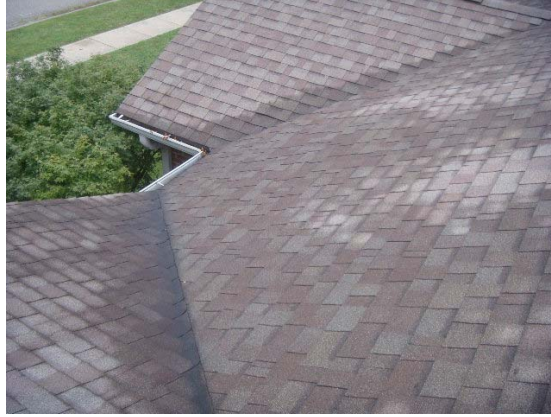
**Location of condition:**        **Above the front entry door.**

- **Improve: Monitor:** There is an area of the roof that drains into a very small area. This area of the roof should be monitored for potential leaks particularly during snow accumulation. This area of the roof may require periodic maintenance and will be a source for ice damming.

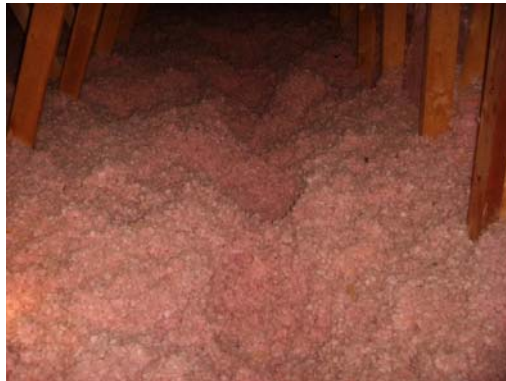
**Location of condition:**        **Middle of the attic where people have walked.**

- **Improve:** The insulation in the attic is compressed/displaced. This condition will reduce the effectiveness of the insulation. Consideration should be given to installing additional insulation.

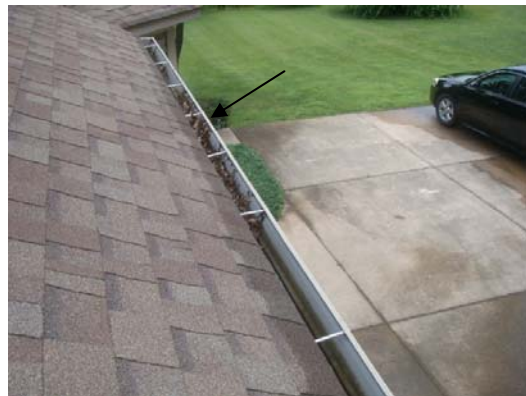
- **Repair:** The guttering is dirty and needs to be cleaned to avoid spillage of roof water run-off next to the building. This water accumulation next to the building may contribute to water penetration into the basement or crawl space, can contribute to movement in foundation walls from hydrostatic pressure, and is conducive to termite infestation and other forms of wood destroying infestation.

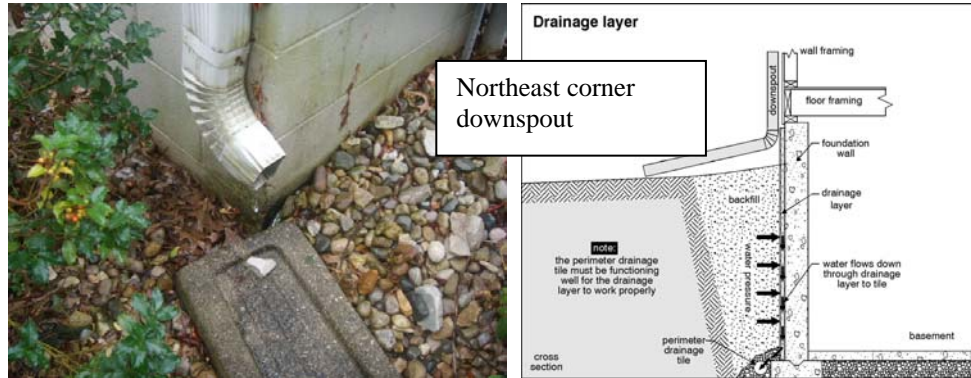
**Location of condition:** Some of the downspouts.

- **Repair:** The downspout is not extended far enough away from the foundation wall. This condition should be corrected to avoid water spillage next to the building. This water accumulation next to the building may contribute to water penetration into the basement or crawl space, can contribute to movement in foundation walls from hydrostatic pressure, and is conducive to termite infestation and other forms of wood destroying infestation.

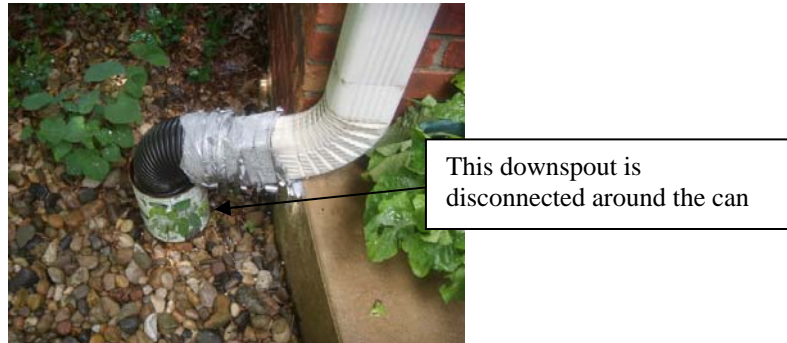
**Location of condition:** The west middle downspout.

- **Repair:** The downspout is not fully extended into the sub-surface drain tile. This condition is allowing water to accumulate next to the building. The downspouts should be fully extended into the sub-surface drains.

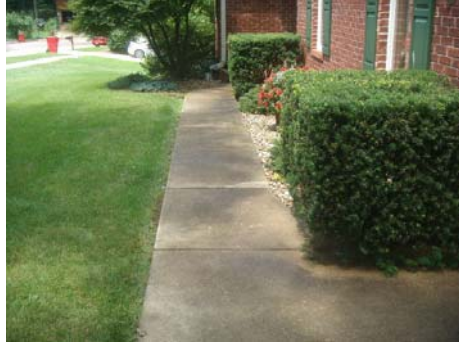
**Location of condition: Front sidewalk.**

- **Monitor: Improve:** The walk has settled and now slopes toward the foundation wall. The resulting water accumulation next to the building, may contribute to water penetration into the basement or crawl space, can contribute to movement in foundation walls from hydrostatic pressure, and is conducive to termite infestation and other forms of wood destroying infestation.

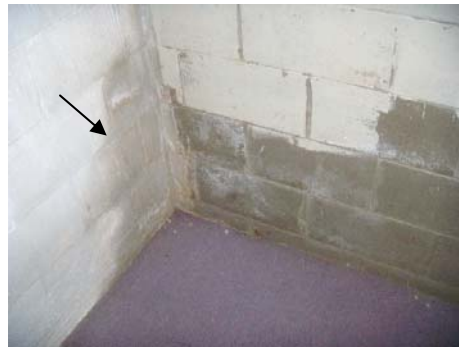
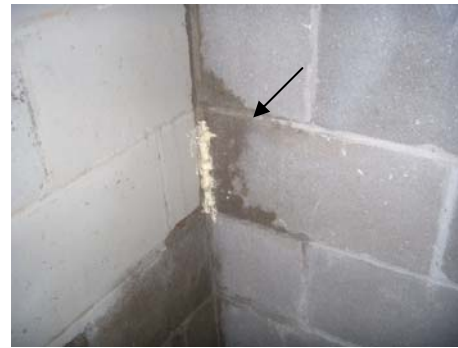
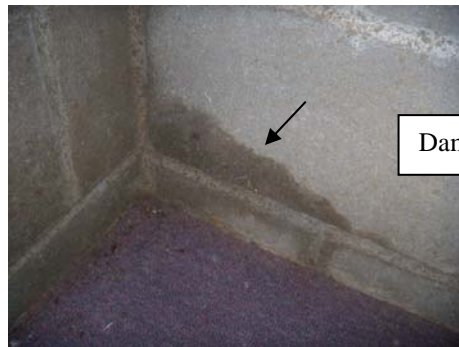
Location of condition: West wall of the laundry room closet.

- Major Concern: Repair:** The basement and/or foundation walls were damp or wet at the time of inspection. *While it is impossible to predict the severity or frequency of moisture penetration on a one time visit to a home, the visible evidence suggests that basement leakage will be a chronic occurrence.* Further monitoring of the foundations will be required to determine what improvements will be required.  
 The vast majority of basement leakage problems are the result of insufficient control of storm water at the surface. The ground around the house should be sloped to encourage water to flow away from the foundations. **Gutters and downspouts should act to collect roof water and drain the water at least five (5) feet from the foundation, or into a functional storm sewer. Downspouts that are clogged or broken below grade level, or that discharge too close to the foundation, are the most common source of basement leakage.**

Damp walls

In the event that chronic basement leakage problems are experienced, excavation, damp-proofing and/or the installation of drainage tiles may be necessary. Your plans for using the basement may also influence the approach taken to curing any leakage that is experienced. If the leakage can be tolerated, expensive repairs can usually be avoided.

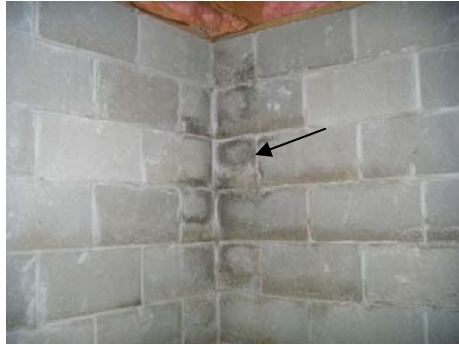
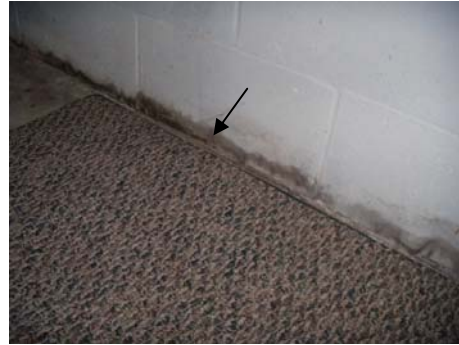
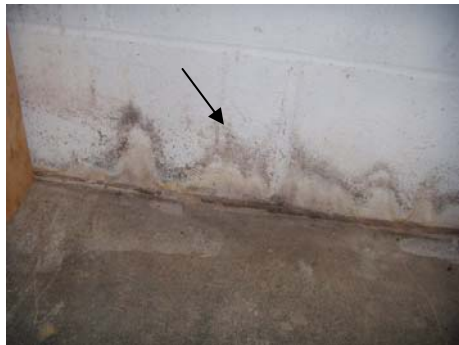
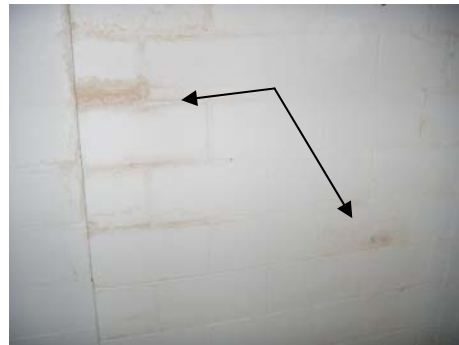
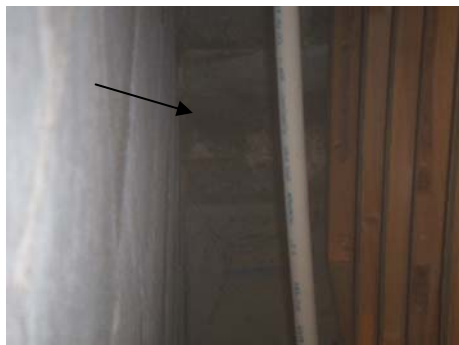
**Location of condition:** Along the north and east basement walls.

- **Major Concern: Repair:** There is evidence that the basement may have gotten some seasonal water penetration in the past. The evidence included but may not be limited to powdery white mineral deposits visible on the foundation walls, stains along walls, columns or mechanical equipment, musty odor or mildew present, storage in the basement elevated off the floor, and/or

an interior water control system that has been added possibly in an effort to address prior water penetration. Please refer to the guttering and drainage section of this report for conditions which may be contributing to water penetration.

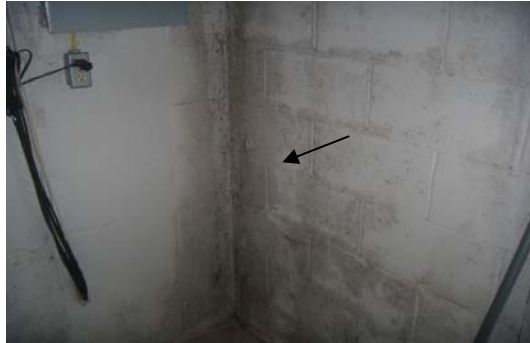
**Location of condition:** Northeast corner of the basement block wall.

- **Improve: Environmental Concern:** There is mold like substance accumulating on the wall or ceiling finishes. Mold generally indicates an elevated moisture content within the home. This moisture may be the result of prior roof leaks, plumbing leaks, mechanical component leaks, water penetration into a basement or crawl space, lack of adequate air circulation, and/or areas where warm and cold air are condensing on the finishes. An effort should be made to reduce the moisture sources and to remove the mold.

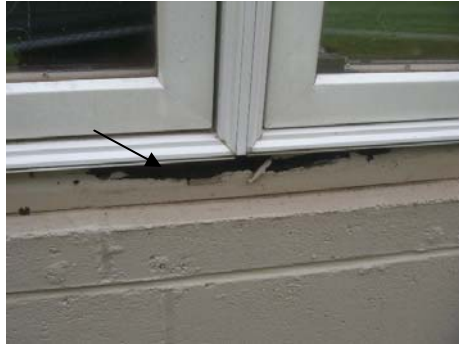
**Location of condition:** Both basement north windows.

- **Repair:** The window trim and/or sill are rotten. The deteriorated wood is conducive to wood destroying insect infestation and should be repaired or replaced as soon as possible.

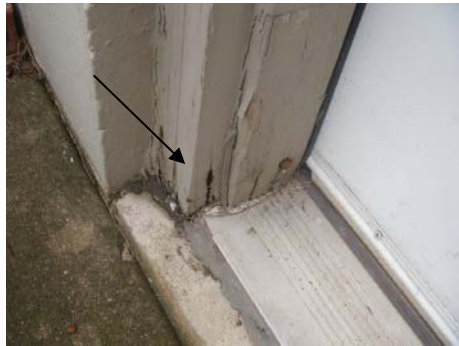
**Location of condition:** Basement exit door.

- **Repair:** The door trim and/or sill are rotten. The deteriorated wood is conducive to wood destroying insect infestation and should be repaired or replaced as soon as possible.

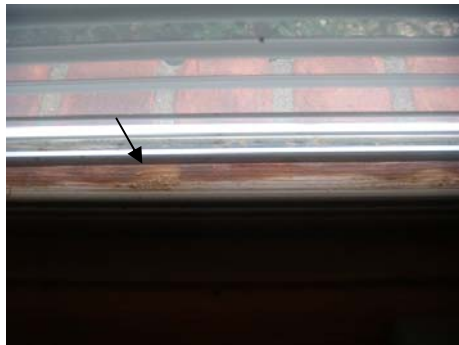
**Location of condition:** The area between the window glass needs refinishing on some of the window.

- **Improve:** There is evidence of localized wood deterioration on the window (s). This wood deterioration should be repaired to avoid further deterioration of the window. The wood deterioration may be associated with the absence of adequate painting, caulking, glazing and/or flashing details.

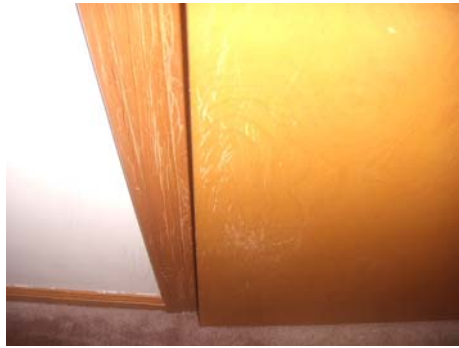
**Location of condition:** North bedroom door.

- **Improve:** There has been animal damage to the door (s). Repair to the door should be considered.

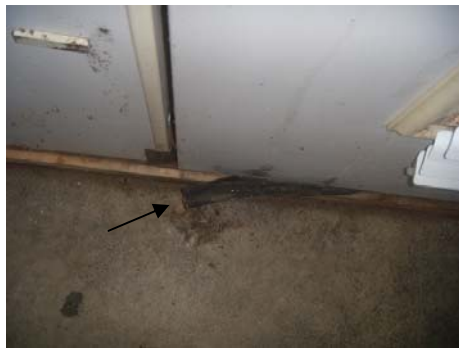
**Location of condition:** Basement exit door bottom weather strip.

- **Improve:** The exit door weather stripping is torn, loose, and/or missing. This condition may contribute to weather and/or insect entry into the building. Repairs should be undertaken.

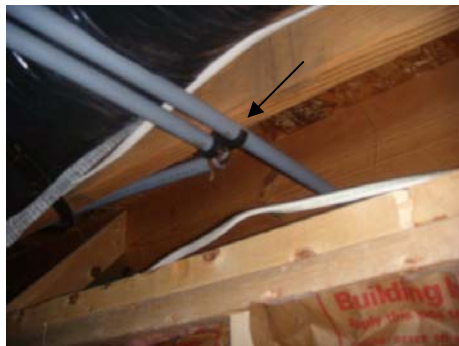
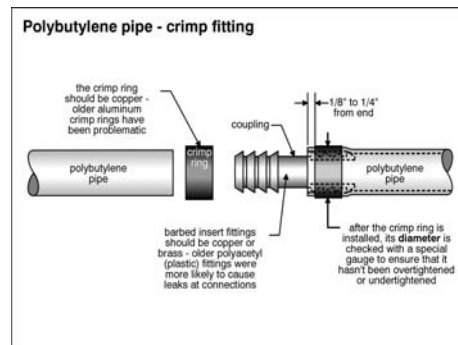
**Location of condition:** Around the water softener. The crimps used on this piping are copper.

- **Monitor:** When the garbage disposal was operated and odor occurred. You may need to install some type of cleaner to eradicate the odor.
- **Monitor:** There appears to be some polybutylene piping present. This type of piping has in some cases proved problematic particularly when aluminum crimp rings are in use. The piping should be monitored for potential leaks and repaired or replaced as needed.

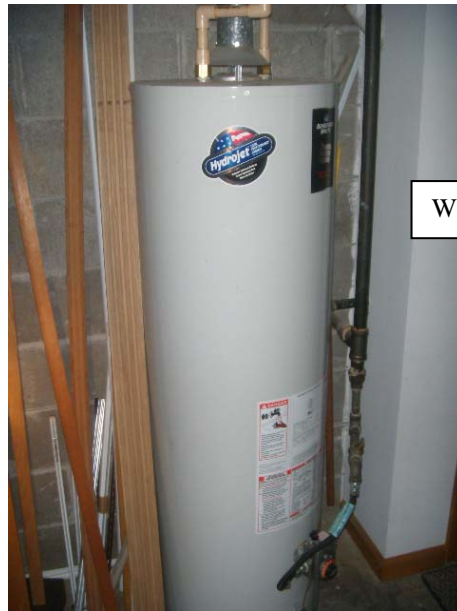
- **Monitor:** The water heater is 15 years old and may be approaching the end of its expected life. Generally, water heaters life expectancies range between 10 and 15 years. Factors such as hard water conditions can shorten this life expectancy.

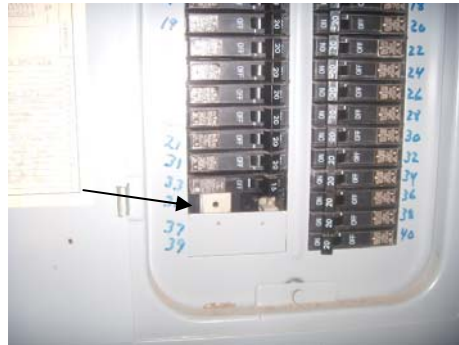
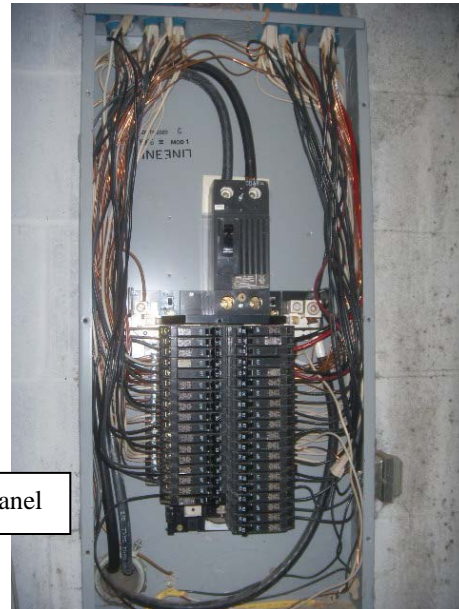
Main panel

- **Monitor: Safety Issue:** There are breakers, fuses, or lugs within the Main panel, and/or sub-panel (s) that service more than one wire. Each device should only service one wire. The risks of servicing more than one wire can result in loose connections, heat, and/or nuisance tripping of the over-current protection device. **The effected device appears to only be servicing the doorbell low voltage transformer and may not create a problem.**
- **Improve: Safety Issue:** The covers over the openings (knock-outs) in the main panel sub-panel (s) are missing. All openings should be covered to prevent an individual from reaching into hot portions of the panel box.

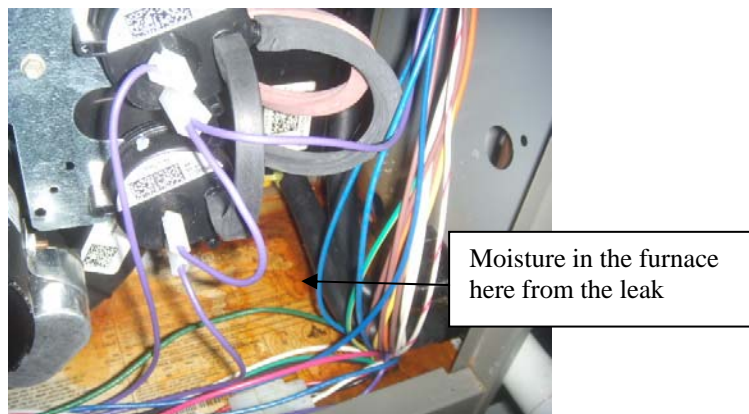
**Location of condition:** There is condensate leaking into the furnace cabinet form the cooling coil above.

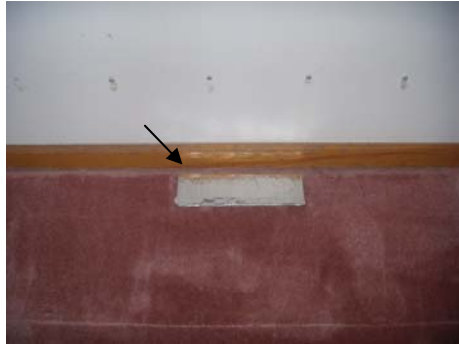
**Location of condition:** Master bathroom closet register and some basement ceiling registers.

- **Monitor:** The supply duct registers plugged or covered.

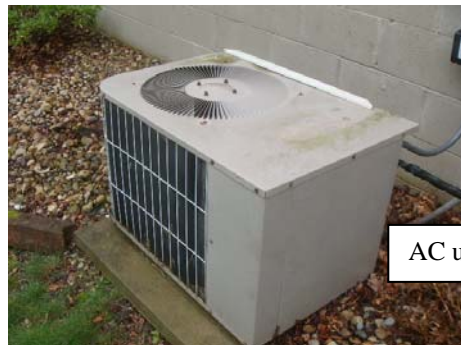
- **Monitor:** The unit is 22 years old and is beyond the end of its expected life cycle.

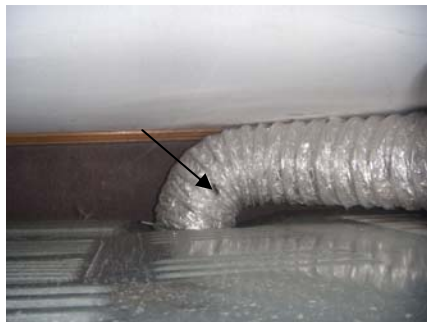
- **Improve:** The clothes dryer exhaust vent pipe has a small hole in it that should be sealed.
