# Building Inspection Report

123 Sherlock Ct; Bloomington, IN 47401

**Inspection Date:**  
07/23/2013

**Prepared By:**  
Sherlock Homes Inspection Svc., Inc.

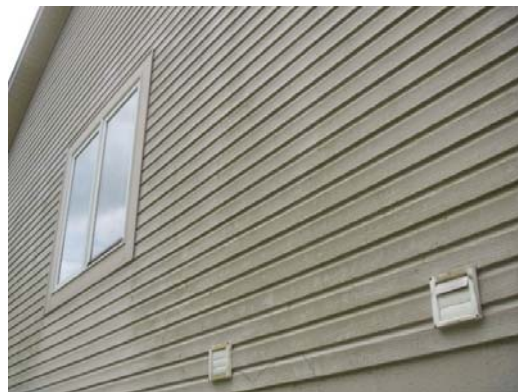
Location of condition: North side of the house siding.

- **Improve:** Algae is accumulating on the siding. The algae accumulation appears to be related to lack of sunlight and/or air flow along this elevation. An effort should be made to clean and remove the algae.

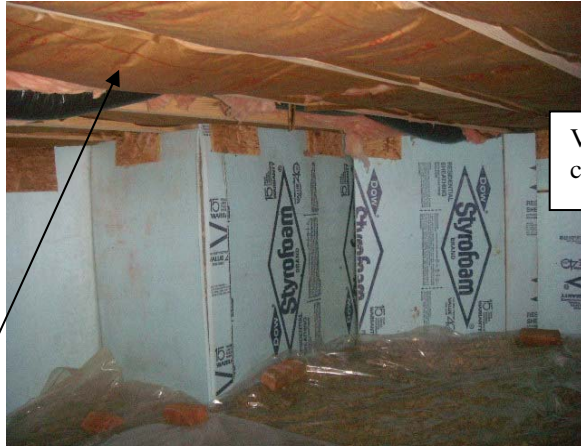
View within the  
crawl space

- **Improve:** The insulation vapor barrier has been installed improperly. The vapor barrier is facing the un-conditioned crawl space. The vapor barrier should be facing the conditioned space/living space or sub-floor. This condition could trap water vapor in the floor cavity.

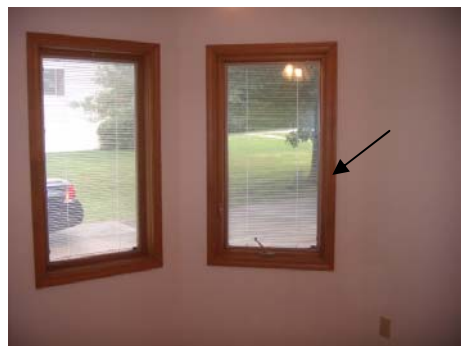
**Location of condition:**      **1-Soth kitchen nook window does not close easily.**

- **Improve:** The window (s) would not fully open or close. Windows which will not fully open may not allow for proper egress in case of an emergency. Windows that are located in a bedroom should get higher priority for repair. Windows that will not fully close may allow for some weather penetration.

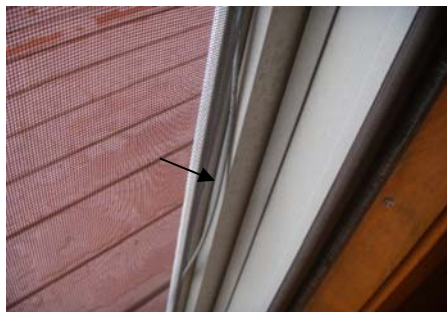
**Location of condition:** Living room exit door screen.

- **Improve:** The storm door screen is loose..

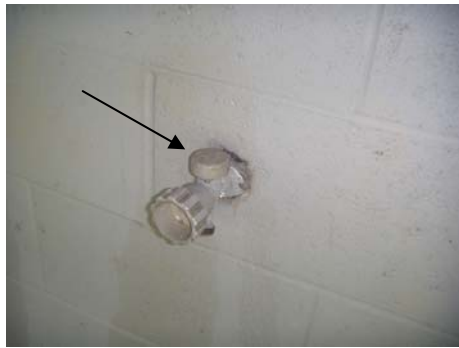
**Location of condition:** Utility sink. Also the rear exterior hose faucet is slightly loose to the wall.

- **Improve:** The following fixtures were loose. The plumbing fixtures should be repaired as needed.

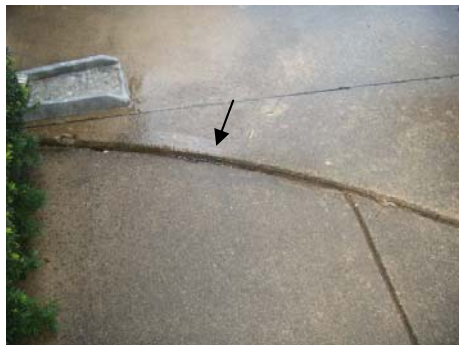
**Location of condition:** Front walk.

- **Improve:** The garage floor shows signs of normal deterioration for homes of this age range. The floor has small cracks, lacks control joints to help control cracking and/or is chipped. The floor should be repaired as needed.
- **Improve:** The overhead garage door may need some adjusting as when it closes it makes a sound as if it were trying to bind.
- **Monitor:** The wood deck is not adequately bolted to the house band board. Ideally leg bolts would be installed within every other floor joist cavity.
- **Monitor:** The deck posts are extended below grade. It is beyond the scope of this inspection to determine the condition and/or the adequacy of the support system below ground.
- **Repair: Safety Issue:** The concrete has heaved, creating a possible trip hazard. The concrete should be repaired as needed.

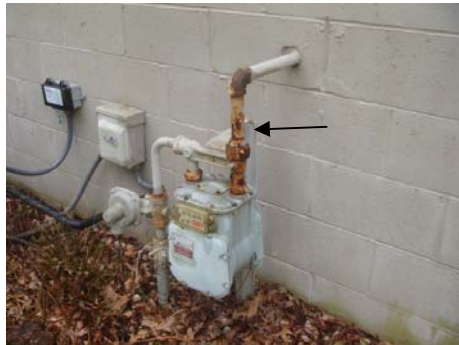
**Location of condition:**            **Outside by the meter.**

- **Safety Issue:** Smoke detectors were not present the bedrooms.
- **Safety Issue:** Ideally carbon monoxide detectors would be present on each floor.
- **Improve: Safety Issue:** The gas piping is rusty. Rusty gas piping can contribute to gas leaks. The piping should be painted and sealed to help prevent further deterioration.
